PIKES CREEK DAM

NDS ID NO. PA-00576

PHASE I INSPECTION REPORT
NATIONAL DAM INSPECTION PROGRAM

JULY 1978

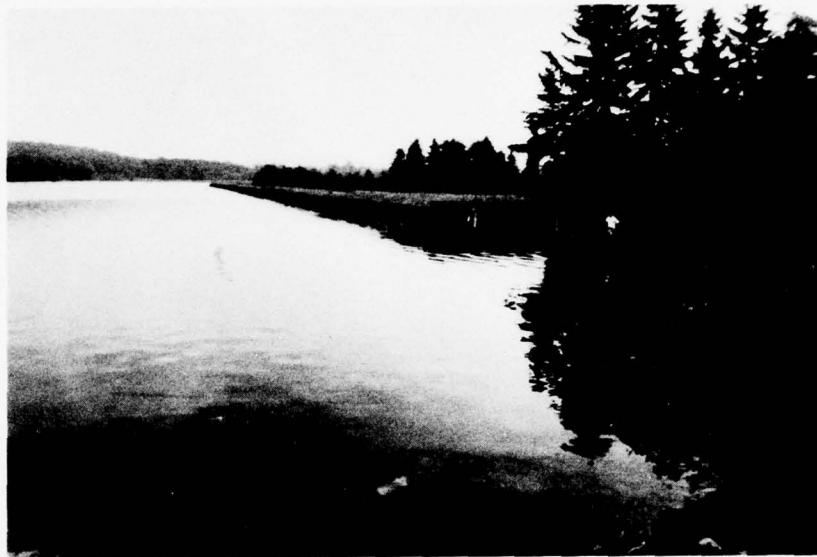
A. Embankment and Main Spillway
View from Right Abutment

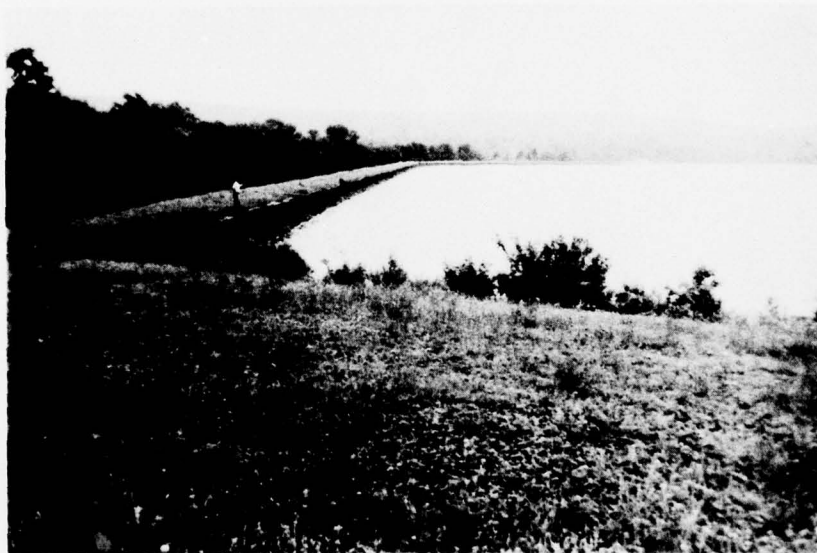
B. Embankment — View from
Auxiliary Spillway at Left Abutment

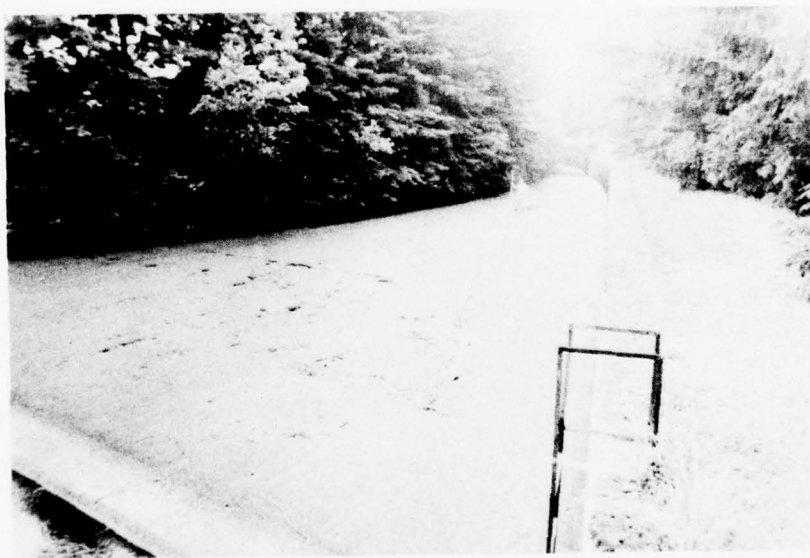
F. Main Spillway Channel
